WHAT HAPPENED IN FUKUSHIMA A TECHNICAL PERSPECTIVE

The Nuclear Accidents at the Mark 1
Boiling Water Reactors (BWR)
at Fukishima Daiichi Units 1 - 4
and Implications for American BWR

LBNL EETD noon Seminar - April 5, 2011

Christian Lobscheid, PE Senior Mechanical Engineer Advent Engineering Services, San Ramon, CA

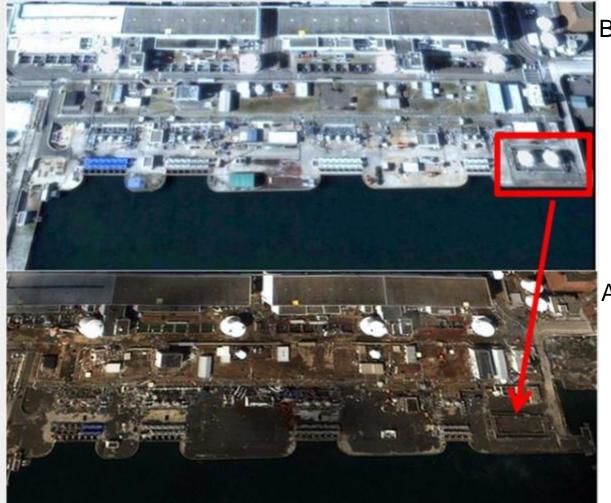
Loss of Diesel Tanks for Emergency Generators

+ Potential Flooding of the 14 Diesel Generators

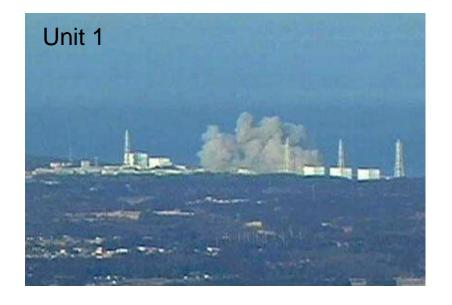
March 12

Hydrogen Explosions of outer Secondary Containment Buildings (Primary Containments Believed to be Undamaged at that Time)

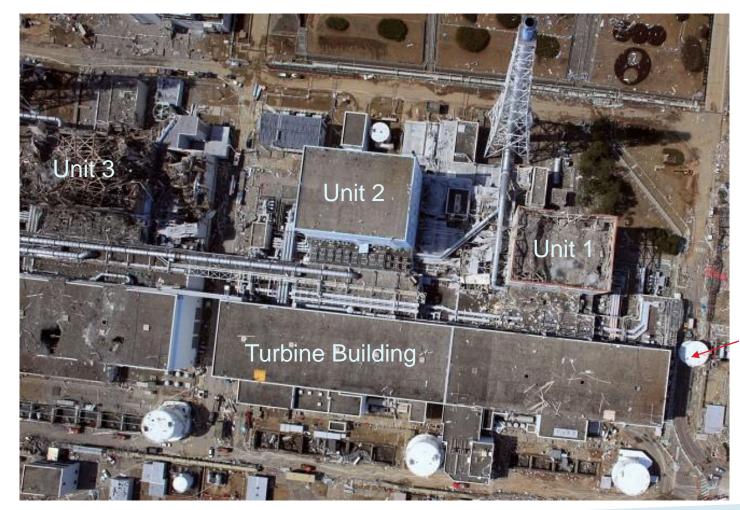
After March 14

March 15 Hydrogen Explosion and Fires in Secondary Containment Building of Unit 4 (reactor was completely emptied before accident)

- Spent Fuel Pool uncovered at Unit 4 (Earthquake damage?)
- Nuclear fuel in pool overheats and also generates hydrogen

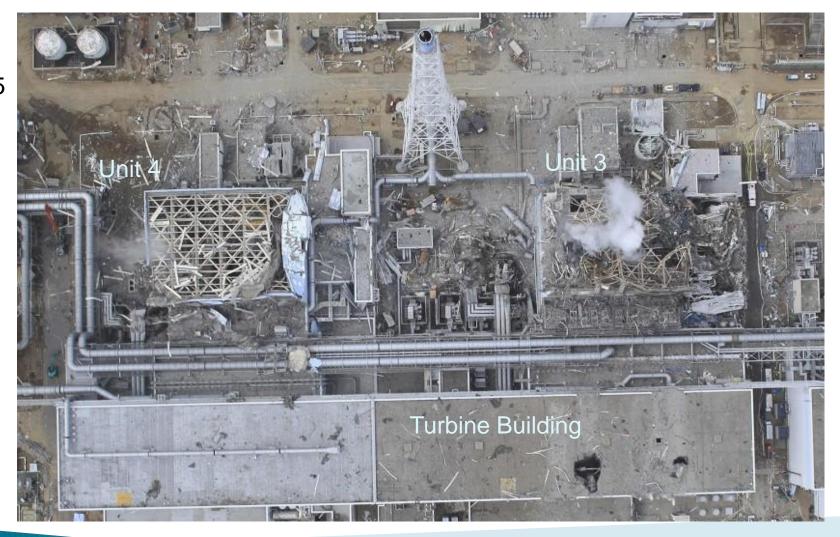
After March 15

Unit 2 appears to have suffered primary containment damage, radioactive decay products (cesium, iodine) and plutonium released into environment.

- Seawater was pumped in with mobile equipment (irreparable damage)
- Helicopters and concrete pump dump water on spent fuel pools

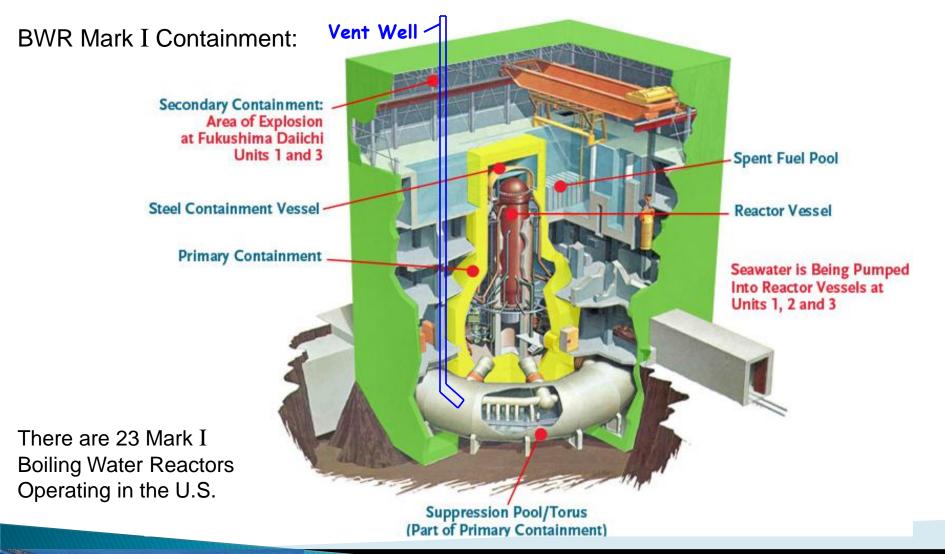
- Quenchers were installed in Torus to distribute the steam bubbles
- Deflectors were installed in Torus to break up the pressure wave
- Primary Containment, Torus, and Internal Piping (especially of the Emergency Core Cooling System) were structurally fortified
- Most importantly, the NRC required 1989 that <u>all</u> Mark I containments have a <u>Hardened Wetwell Vent</u> installed (NRC Generic Letter 89-16) (like the barrel on a rifle, strong enough to withstand explosion within)

Japan's Nuclear Safety Commission rejected requirement of Hardened Wetwell Vent in 1992 – it should be left to the plant operators to decide
